Longbridge Deverill Roundhouse Experiment Report

David Freeman & Simon Jay

Experiment: 2nd November 2006

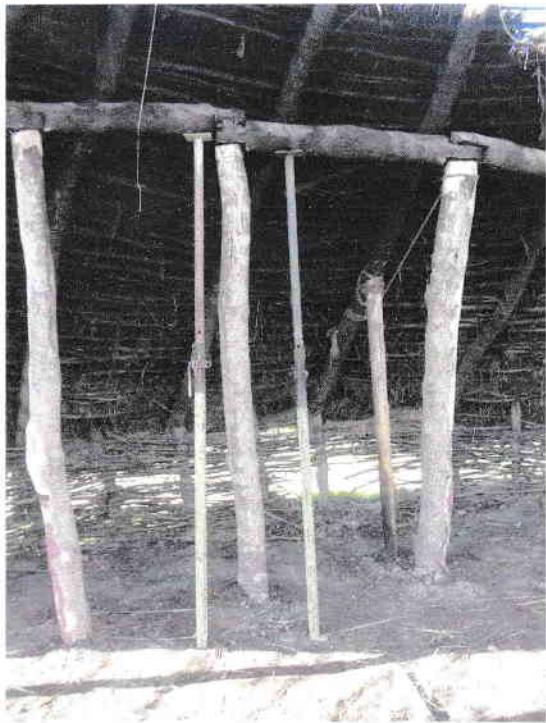
Fig. 1

We fitted the acros 8 inches either side of post number 10 in the roundhouse to support the structure (Fig. 1). We then slowly began to wind up the apparatus so that the ring beam lifted (Fig. 2), however it appeared that the post began to lift with it, out of the ground (Fig. 3). After the whole thing was raised 4 inches, we found it possible to lift the post out. This was due to the fact that the post had rotted inside the ground which we had not predicted (Fig. 4)

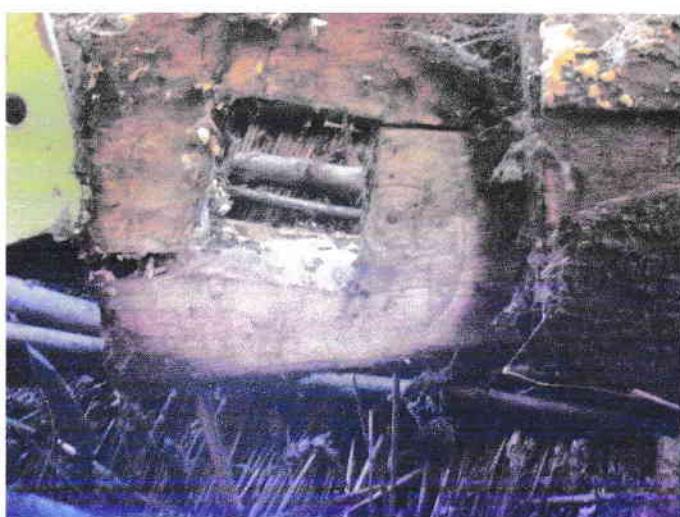
Fig. 5

Having taken the post out of the structure, we observed that the mortised holes had not moved (Fig 5). As they were still in alignment, we then fitted the original post back in again (in theory, we would have fitted a new post but there seemed to be little point as the roundhouse was due to be rebuilt).

We then lowered the ring beam down onto the post again and the structure was complete.
