The scientific basis for the reconstruction of prehistoric and protohistoric houses

■ † Peter J. REYNOLDS
Butser Ancient Farm (UK)

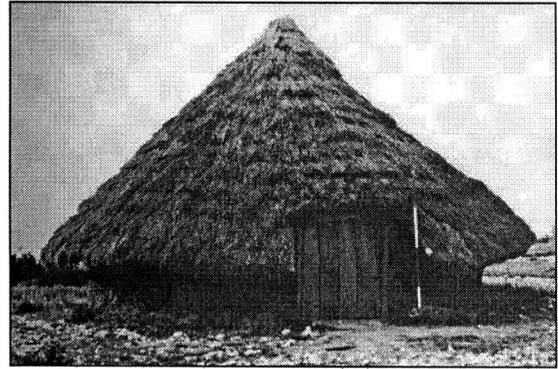
■ Fig. 1 Maiden Castle house: the completed structure. Set on the exposed spur of Little Butser this house has withstood hurricane force winds with impunity. Aerodynamically its shape is ideal. At no time is a flat surface presented against the elements (in: Reynolds 1979, 35).

The plan for this reconstruction was drawn from the excavations of Maiden Castle in Dorset. Specifically the plan for Hut Db was used as the basis for this reconstruction, the first to be built at the Butser Ancient Farm Research Project on Little Butser (Reynolds 1978). Essentially the plan comprised a circle of post-holes with a centrally placed post-hole. It was decided to build this structure using the simplest technology, the only joints being the mortice and tenon joints joining the lintel to the door posts. The walls were interwoven with hazel rods creating a very strong basketry frame, the full cylinder being completed with the lintel span across the doorway. In all

such reconstructions of simple as opposed to complex roundhouses it is necessary to prop the doorposts to counteract the outward thrust of the basketry walls. A central post with a Y fork was set into the centre of the floor to support the roof apex, the angle of the roof being at the critical functional angle of 45° to the horizontal. At angles of less than 45° and more than 55° thatched roofs leak (see below Balksbury House). The initial tripod of rafters were laid into the Y fork and lashed to the side of the wall uprights with rawhide thongs. A supplementary ring was attached to the tripod one third down the slant height of the rafters and to it were attached the remaining rafters, the ends of which were similarly lashed to the sides of the uprights in the wall. The house was completed with the application of daub to the walls inside and out and the roof was thatched with straw. A door of split oak planks was fitted to the doorframe with pivot hinges set in the lintel and a sill set on the ground surface.

For a period of ten years this structure fulfilled all expectations. It successfully withstood extremes of weather including tornado force winds, heavy snowfalls and torrential rain. After this time, however, the rawhide lashings began to fail and the roof began to move downward roughly at a rate of 50 mm per annum. Gradually the wall posts began to protrude through the roof, the brittle wall cladding giving way under the weight thrust. As the roof descended the central support post caused the rafters to pull inwards at the wall circumference in a similar behaviour pattern to an umbrella closing. Finally the roof twisted through approximately 15° causing partial wall collapse with the original tripod held in place by the central support erupting through the apex of the thatch. In all senses the structure failed.

fail subsequently. Two structural elements were in error. The rafters must be set upon the top of the wall posts probably with a simple notch, and secondly the central support pole is totally unnecessary to the structure. In all probability an alternative interpretation for this feature should be proposed where it will fulfil a non-structural role.

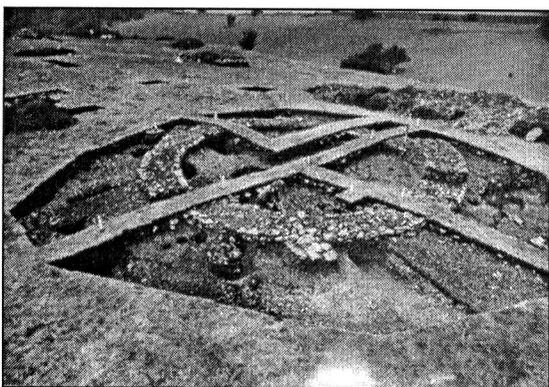
■ Fig. 2 Conderton House as exposed by excavation (in: Reynolds 1982, 191).

Excavations at Conderton Camp on Bredon Hill, Worcestershire (*Thomas 2005*) revealed the foundations of a stone-built roundhouse. The structure survived as two courses of dry stone footings of an Iron Age house with a paved porch. The internal diameter was 6.09 m, the external diameter 7.91 m, the walls averaging 0.91 m thick. The doorway was quite narrow at just 0.90 m in contrast to the great majority of timber houses. There was evidence of a collapse of some 2.80 m of the wall around the circumference in the north-east quadrant. During the excavation, an experiment was carried out to attempt to establish the original wall height. Stone collapse was carefully gathered from a segment of the excavated area centring on the middle of the house and extending to the limits of the excavation. All the rem-

nant stone rubble was gathered and rebuilt onto the section of wall contained within the segment. The resultant height of the wall was about 0.80 m. This trial begs a number of questions, not least of which is the potential re-utilisation of fallen stone in local field walls, which are a common feature of the field boundaries on the hill. It is likely that any collapse material would have been thoroughly overgrown had it been left in situ originally, forming a mound of which a large number remain to this day and to which was ascribed local suspicious tradition (*Reynolds and Lloyd 1967*). More importantly, the kind of stone used in both the house and the field walls of two millennia later can be found simply by digging into the hillside, especially on the oolitic limestone capping. The large number of quarry pits on the hill suggest that the field walls were created from freshly-quarried stone. The exercise, therefore, had considerable value and allowed one to suggest that the original wall could have been but a little higher than the trial showed.

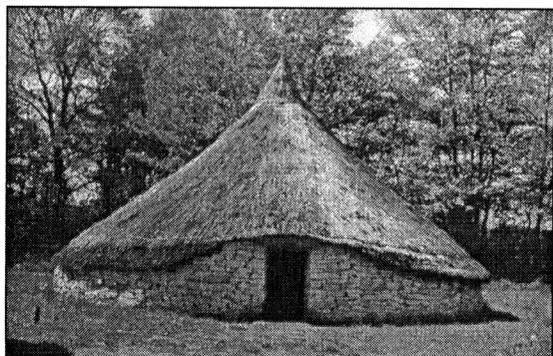
■ Fig. 3 Conderton House completed (in: Reynolds 1982, 195).

The structure was built at the Avoncroft Museum of Buildings near Bromsgrove in Worcestershire. The construction of the stone wall was, in a sense, the easiest element. It required no less than 50 tonnes of limestone and was built up to accommodate a doorway just 1.30 m high.

The major difficulties began when the alliance of disparate materials had to be forged. It was appreciated that the roof would exert considerable lateral thrust on a dry stone wall, which is generally regarded as unstable in such conditions. Indeed, the original showed clear evidence of a collapse. Mathematically the lateral pressure exerted on a point of moment is least at 45° and most at 22.5° and 67.5°, but nonetheless there is still pressure. A series of trials was carried out to seek the best system of sustaining that pressure. The obvious method was to spread the load along a length of wall rather than allowing a pressure focus on the area of the butt of a rafter – some 0.02 m². The obvious was recognised after the first tripod of rafters caused three points of wall collapse. Thereafter a series of trials was carried out with baulks of timber of differing lengths being forced against the top of the wall with pressure being exerted at 45°. The motive force employed was a Land Rover. The objective was to replicate the 2.80 m wall collapse of the original excavation. This was

The system of thatching employed was to cover the roof structure with a thick layer of hay which meshed into the interwoven willow withies and formed a support into which the straw thatch could be pegged. Over a tonne of hay and two tonnes of straw were used. The total dry weight of the roof was in excess of 5.5 tonnes. Thus a roof with a free span of over 6.0 m and weighing almost 6 tonnes was supported by a dry stone wall.

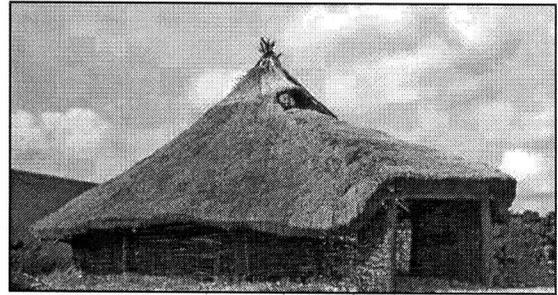
■ Fig. 4 The finished Balkeesbury house (photo Reynolds).

Excavations at Bawksbury, Hampshire (*Wainwright and Davies 1995*) revealed a post-built roundhouse 9.10 m in diameter with the post-holes at intervals of 1.90 m around the circumference and an extended porch or entrance on the eastern side some 2.00 m long. A reconstruction was attempted because the wall posts indicated a different building technique to interwoven basketry. On this occasion a wall plate was set on top of the posts with mortice and tenon joints to create the base cylinder. The spaces were filled in with wattle hurdling which was by definition non-structural simply serving as a base for the daub. The roof structure conjectured included an integrated porch. In the building of a cone shaped roof, as

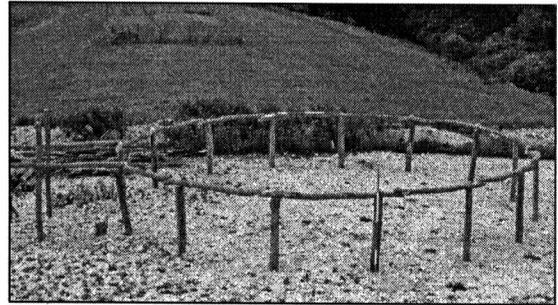
■ Fig. 5 The framework of the Balkeesbury house. Unlike the Maiden Castle house, its strength is drawn from the continuous wall plate attached to the uprights with simple mortice and tenon joints (in: Reynolds 1979, 94).

indeed in any angled roof, the timbers require to be stressed a third the way down the slant height of the roof from the apex. In practice the stress point serves to hold the roof apart counteracting the natural sag of timber along the length. In this structure coincidentally the measurement from the apex to the wall at a 45 angle exactly equalled the measurement from the stress point to the outer lintel of the porch. The angle generated at this point was a little below 40° and was judged at the time to be worth risking, or alternatively, testing. The completed structure was extremely elegant with sweeping curves in the thatch and an impressive porch. It proved extremely strong but, in fact, was doomed to destruction. The roof over the porch, below the critical functional angle, gradually began to leak, the reed becoming saturated and steadily increasing in weight. Within the space of three years the porch roof was horizontal, the rest of the cone being dragged down uncompromisingly. The house was dismantled as a failure. The failure was generated simply by disobeying a structural law. In the event it has been hypothesised that the original excavation revealed only part of the building plan of this structure, that being the inner ring of posts. All evidence of the outer wall had disappeared (*Guilbert 1981*), the original plan being similar to the Pimperne House (q.v. below).

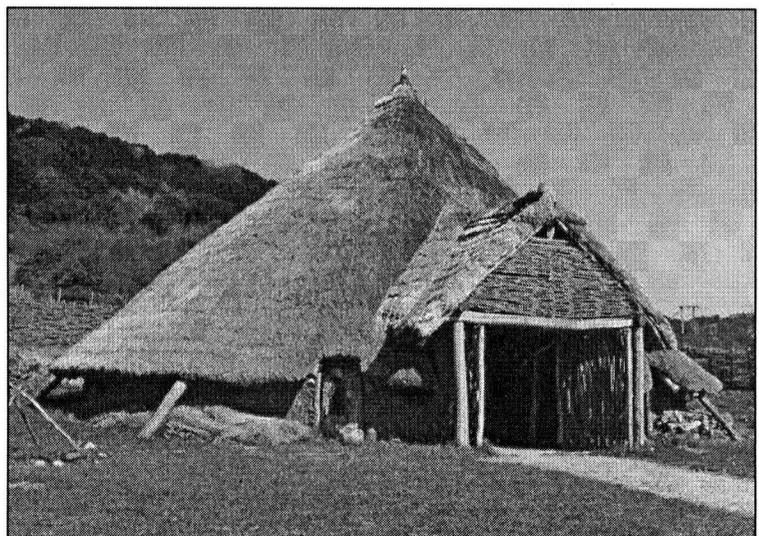
■ Fig. 8 The completed Pimperne house: the focal point of the Demonstration Area, this structure is the largest reconstruction of a prehistoric roundhouse ever undertaken anywhere (photo Reynolds).

The completed structure is quite remarkable, if only in terms of sheer scale and material requirements. Over two hundred trees were needed to build the structure, ten tonnes of daub to plaster the walls and five tonnes of thatch to clad the roof. The information yield at construction was high.

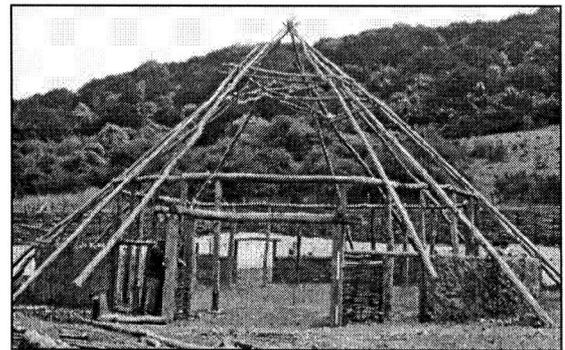
■ Fig. 7 The Pimperne house: the six principal rafters in position (in: Reynolds 1982, 184).

Similarly the six principal rafters, so critical in the preliminary stages of roof construction, have now rotted at the ground interface. In fact, once the building was completed in 1977, the ground was dug away from the butts of these rafters in order to determine if they were still load-bearing. The fact that they weren't, further substantiates the claim of distinction between constructional and structural evidence. The butts of these rafters were left as they were to test their longevity in an exposed position. Like the porch posts they were badly rotted after a mere eight years but only below the limit of the eaves of the building.

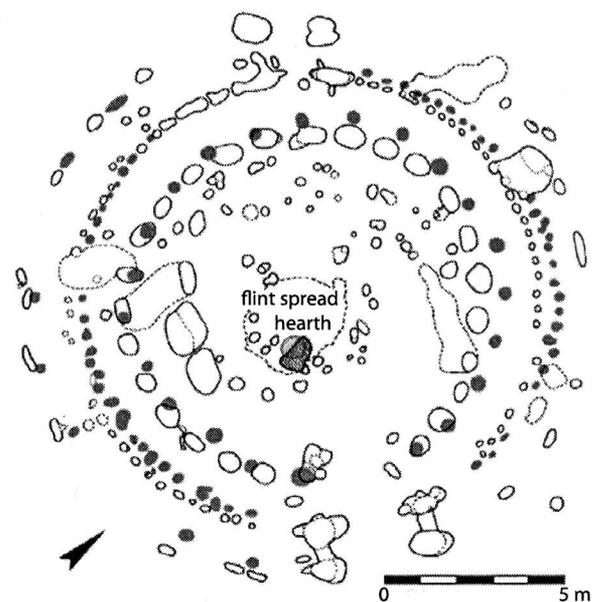
■ Fig. 6 Plan of the excavated site at Pimperne Down, Dorset. The postholes used in the reconstruction are shown in heavier outline. (in: Reynolds 1979, 96).

This is, without doubt, the largest roundhouse reconstruction undertaken by the author. The detailed analysis of its reconstruction has been published (Reynolds 1982) with both the excavation report and building study in preparation (Harding, Blake and Reynolds 1993). It is based upon a limited excavation of a house plan at Pimperne Down in Dorset. The plan and photograph of the excavated area provide the primary data. In effect two houses were built utilising the same porch post-holes for each structure. The outer wall comprised a perimeter of stake-holes containing an inner ring of post-holes. The distance between post-hole ring and stake-hole perimeter was just 1.50 m. At a distance of 1.50 m beyond the perimeter of stake-holes were a number of curved scoops around the circumference of the building. Internally there was evidence for a hearth and a cooking oven as well as a background scatter of post-holes which seemed to have no structural purpose.

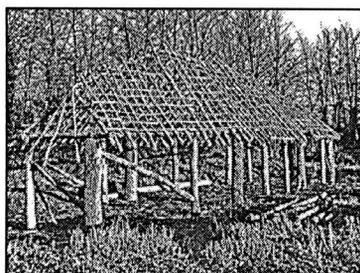
■ Fig. 11
The framework of the Wroxeter house.

The object of the reconstruction was to test the hypothesis that the evidence could actually sustain a structure. To that end the archaeology was faithfully replicated, the end product being a bow-sided hog-backed building asymmetric about the central latitudinal axis. The evidence indicated a framed building but without sill beams, the walls being presumed to be wattle and daub. The end product fully justified the interpretation and, therefore, the reconstruction. However, the life of the building itself was chequered. The first phase, where the wall comprised the uprights bearing the roof of A frames locked into position by the purlins and braced by the hipped gables, suffered the indignity of being blown down along its length like a house of cards. It was successfully re-erected and thereafter cross-braced diagonally across each bay. The result of the construction, there-

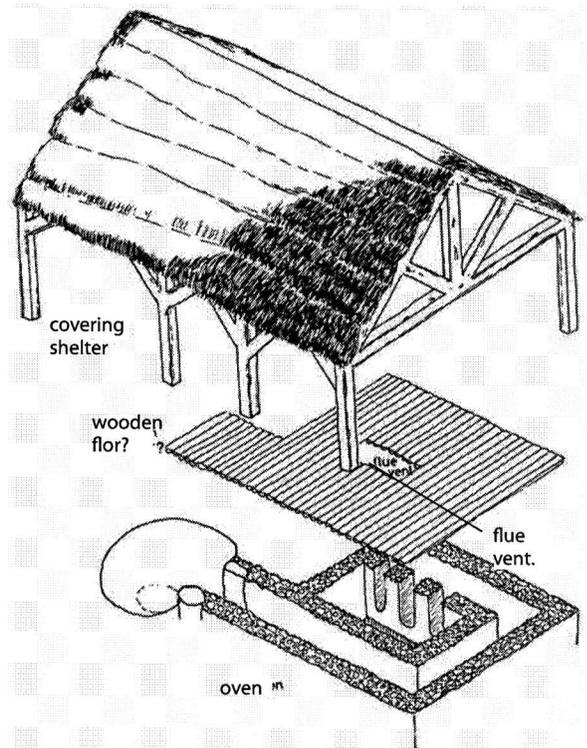
■ Fig. 9
Foxholes farm - exploded view of a suggested reconstruction of a corndryer 5 (in: Partridge 1989).

Reconstruction can be particularly valuable in testing the hypothesis of a function. On a large number of Romano-British sites distinctive subterranean flues have been recovered and identified as grain driers and ascribed as an agricultural innovation necessitated by the British climate on one hand and on the other improved Roman agricultural technology. The author was approached to reconstruct two of these so-called grain driers and test their function. Two sites were used, one from Foxhole Farm in Hertfordshire (Partridge 1976), the other from Barton Court Farm in Oxfordshire (Miles 1984). The reconstructions replicated the evidence from the two sites, with logical extension to include a necessary superstructure (Reynolds and Langley 1979). Subsequent testing proved incontrovertibly that they were not grain driers and were in all probability malting floors. Or at least the malting floor hypothesis was val-

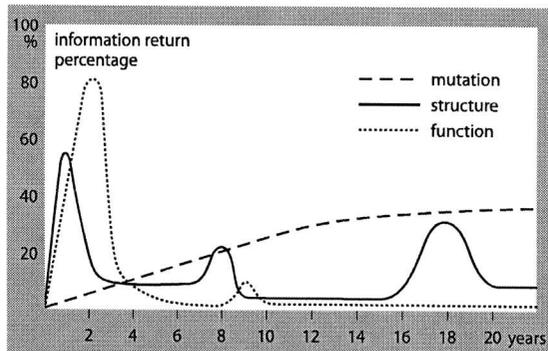
■ Fig. 12 Information return / learning curve.

The ideal approach outlined above presents a full cycle for a reconstruction, as in any ideal it is an extreme case. There is no doubt that the learning curve is strongest at the in-

itial construction stage, the yield of information levelling off significantly after completion and becoming increasingly less after approximately fifteen years. Since this is the case, reconstruction can be categorised to include those designed for museum purposes, educational motives as well as components of integrated long-term research programmes. There is no reason whatsoever why any reconstruction should not be a part of the excavation/interpretation process initially, and thereafter fulfil alternative requirements. However, this will only happen if the reconstruction is site specific and is motivated by the requirement for answers from questions raised by the excavated data. This approach is the more desirable because of the not inconsiderable costs involved and the need to maximise a return from the investment. Further there is a clear element of responsibility to the public at large who invariably, directly or indirectly, provide the funding both for excavation and interpretation. A generalised reconstruction without any scientific basis is no more than a simple insult. Particularly marked are the occasions when the public includes building engineers, architects and craftsmen, all of whom are probably better qualified to assess the building in question rather than the archaeologist who is straying beyond his brief. Loss of professional credibility can be damaging especially when caused by elementary errors, the most common of which is found not so much in physical reconstruction but rather in reconstruction drawings. Regularly a splendid archaeological report of an excavation is marred by a drawing of a structure which would defy physical realisation. Such 'paper tigers' are to be avoided. Indeed, this aspect alone must be adequate justification for reconstruction.
